### **TOWN OF FLOWER MOUND ENVIRONMENTAL CONSERVATION COMMISSION REGULAR MEETING**

**May 1, 2018**

1. Consider a recommendation to the Planning and Zoning Commission and Town Council of a Concept Plan for the proposed Pepper Creek Ranch cluster development. The property is generally located north of Cross Timbers Road and west of Montalcino Boulevard.
2. Consider an application for a tree removal permit for two additional (2) specimen trees on property proposed for development as Lakeside Crossing. The property is generally located south of Lakeside Parkway along and between Long Prairie Road and Northwood Drive.
3. Consider a recommendation to Town Council of a resolution to adopt the Denton County Greenbelt Plan.

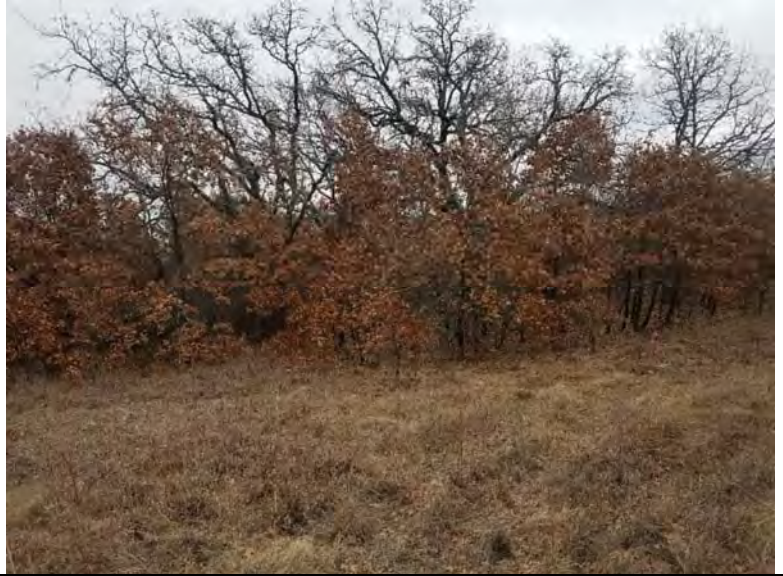
## Photograph 1

Upland habitat in southwest corner of Site looking west from access road.

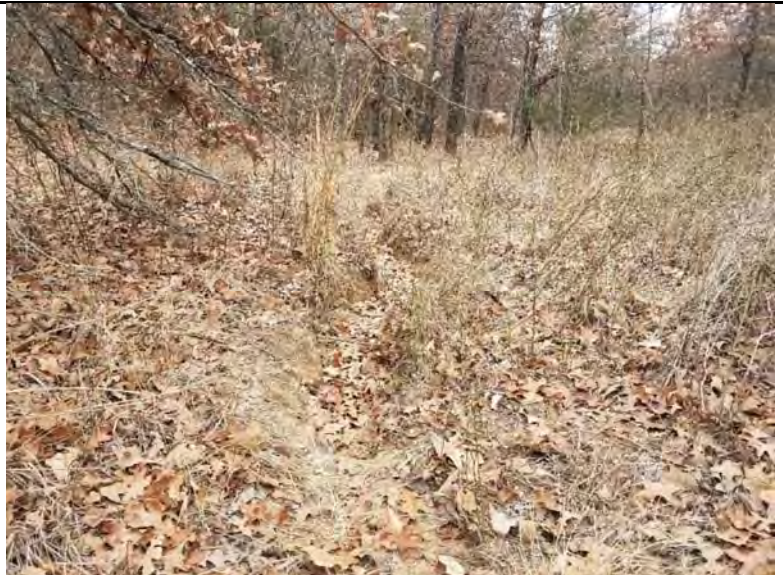
## Photograph 2

Swale-1 in south-central portion of Site facing south-southeast as swale enters wooded area.

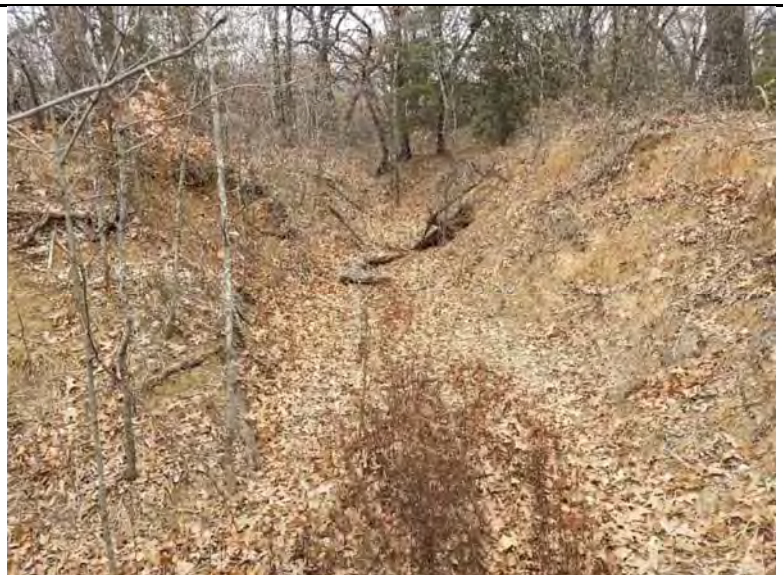
## Photograph 3

Ephemeral stream ES-1 in south-central portion of Site facing north from near south boundary.

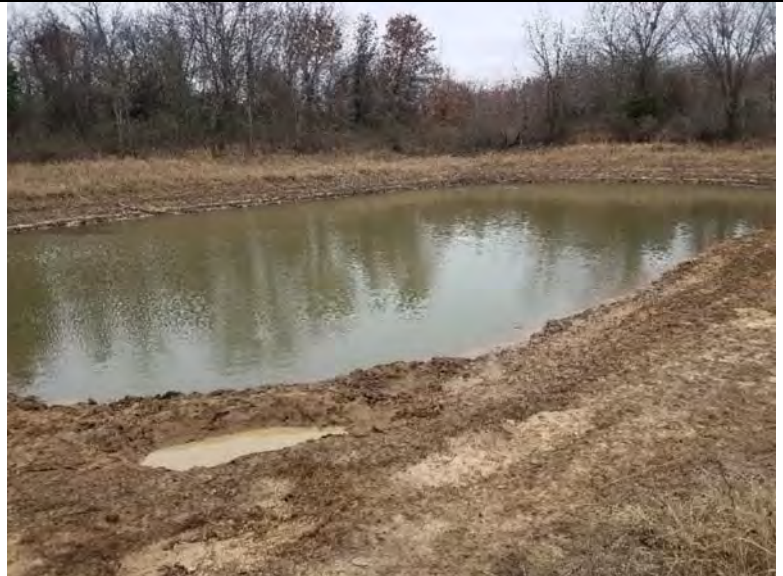
## Photograph 4

Pond-1 in south-central portion of Site as viewed from northeast corner facing southwest.

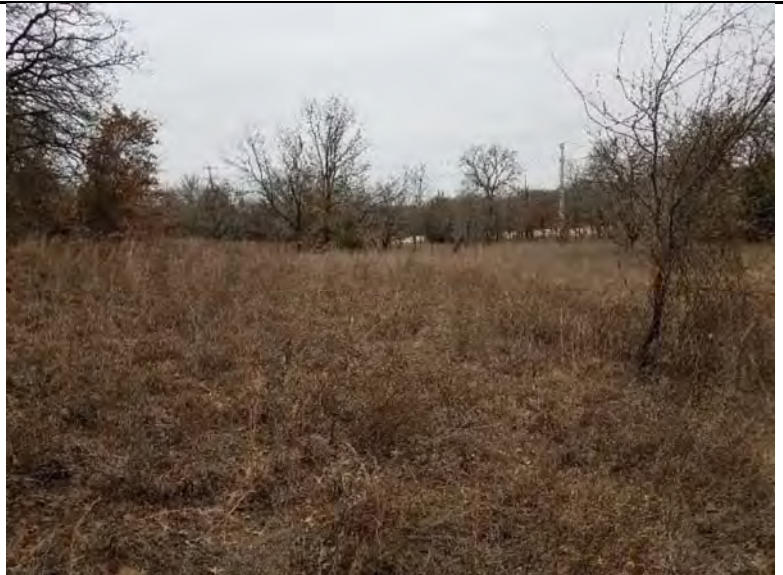
## Photograph 5

Prairie habitat in southeast portion of Site facing south with FM 1171 visible in background.

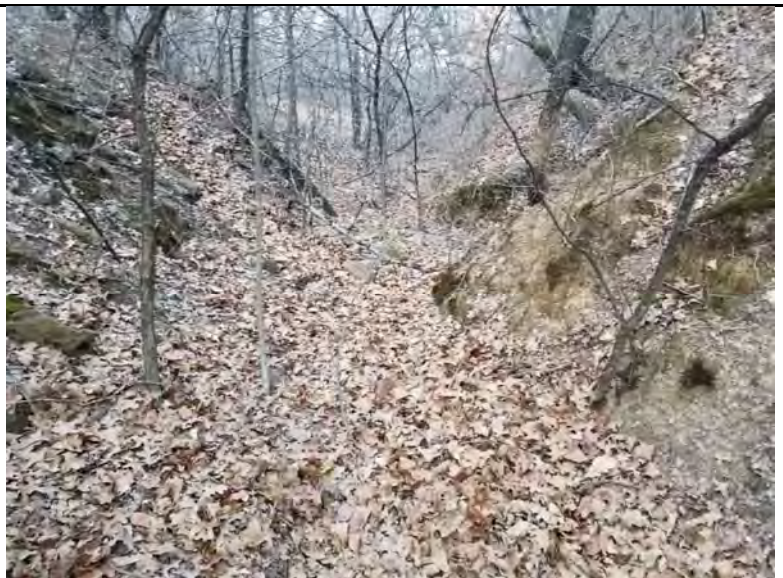
## Photograph 6

Ephemeral stream ES-3 in west-central portion of Site facing west from within the western half of stream.

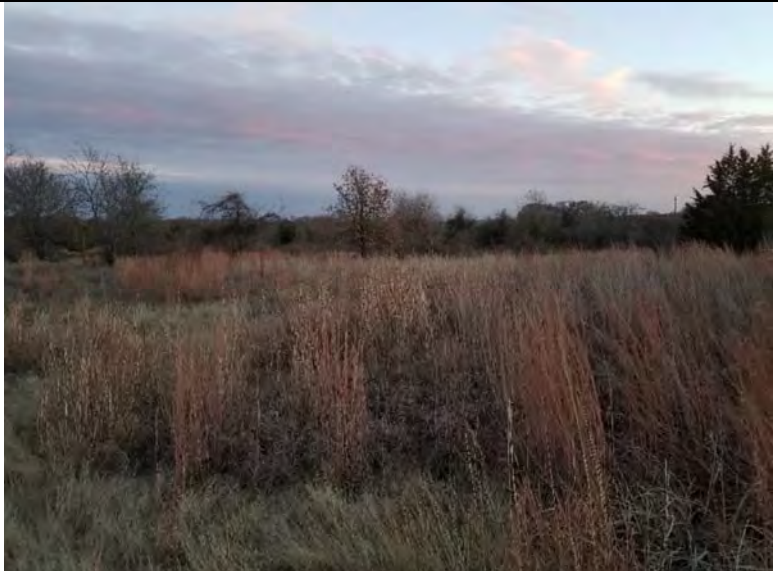
| <p><b>Photograph 7</b></p> <p>Prairie habitat in west-central portion of Site on east side of access road facing south-southeast.</p> | |

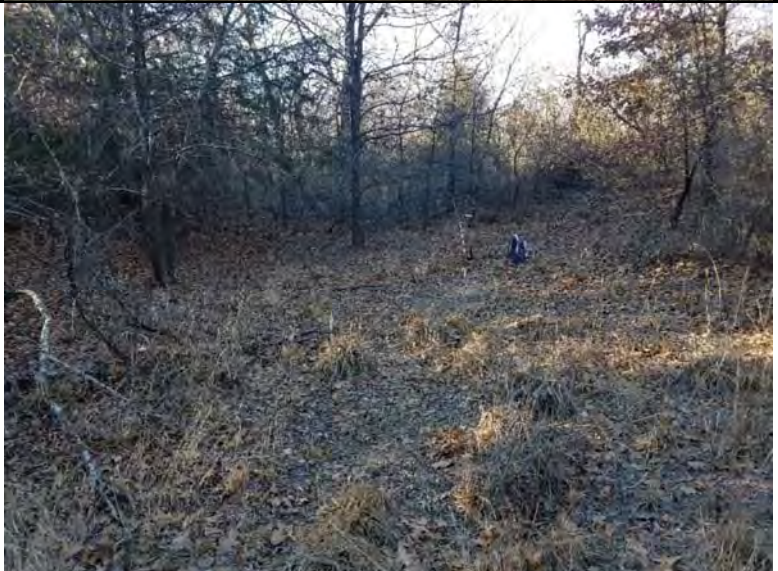
| <p><b>Photograph 8</b></p> <p>Setting of test plot TP-1A in depression within small valley. View is facing south with low, breached berm in background.</p> | |

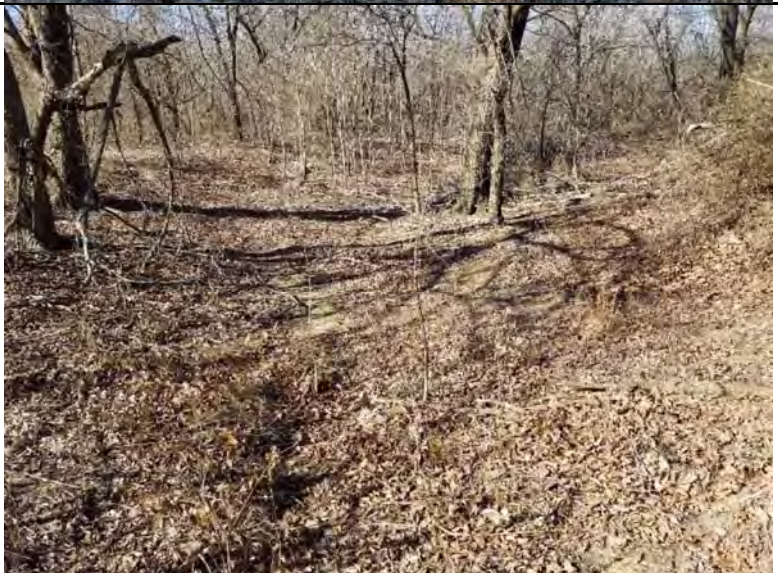
| <p><b>Photograph 9</b></p> <p>Ephemeral stream ES-11 in northwest corner of site with Pond-2 embankment visible to the right. View is to the north-northeast from southwest of the pond.</p> | |

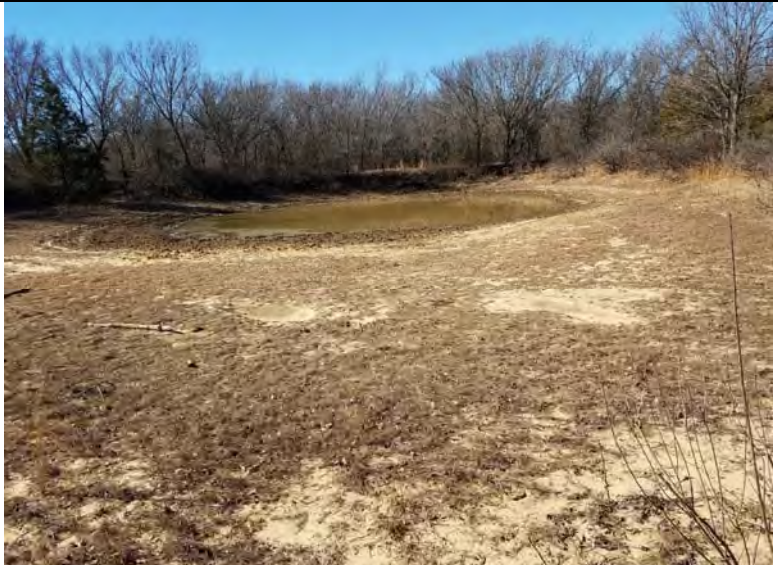
| <p><b>Photograph 10</b></p> <p>Pond-2 as viewed from the northeast corner facing southwest.</p> | |

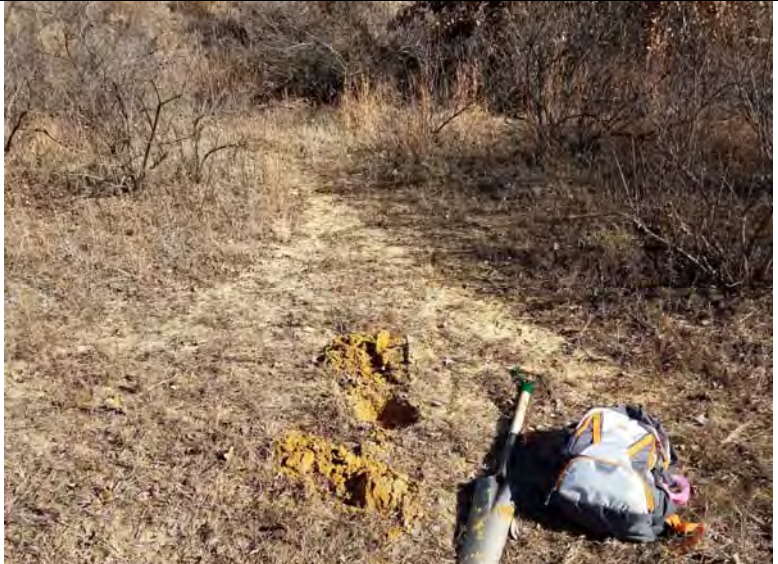
| <p><b>Photograph 11</b></p> <p>Test Plot TP-2A in the northwest corner of Pond-2. View is to the east where animal trail descends from the east to the pond.</p> | |

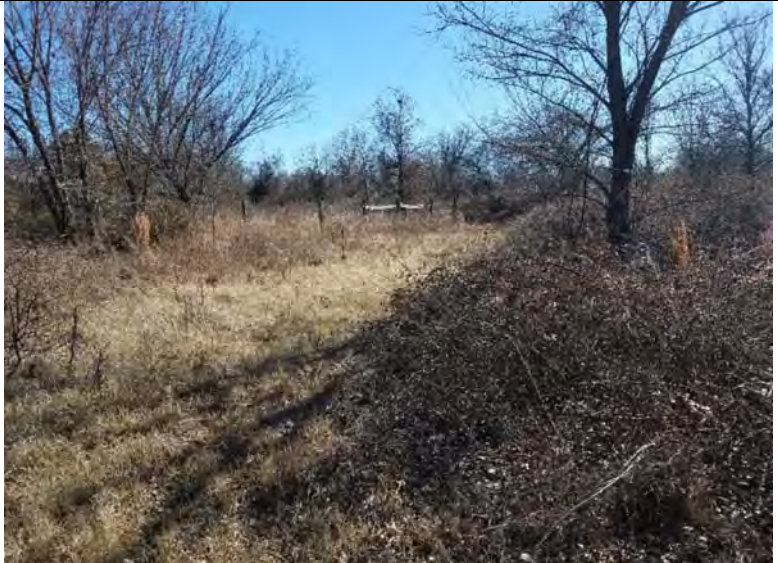
| <p><b>Photograph 12</b></p> <p>Broad swale in area south-southeast of Pond-2 in general vicinity of TP-2C. View is to the southeast.</p> | |

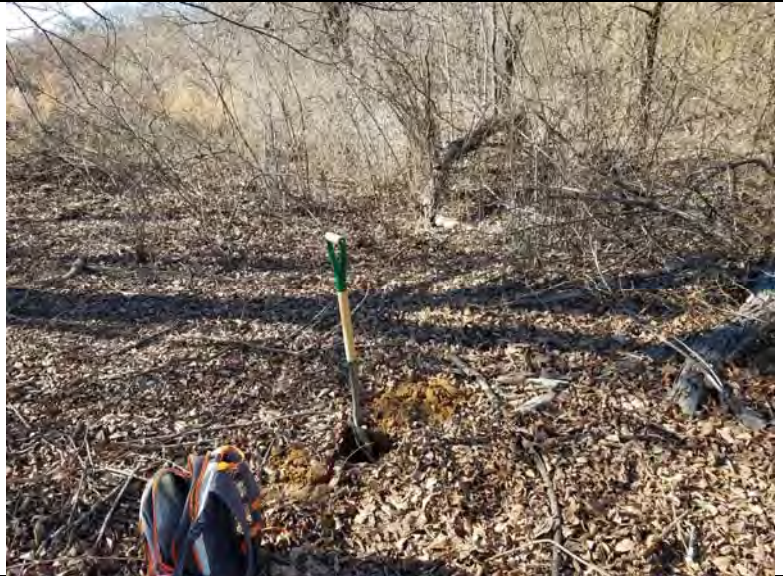
## Photograph 13

Test plot TP-2B in lowest area outside Pond-2 between ponds lowest area and start of ephemeral stream ES-11. View is to the northwest.

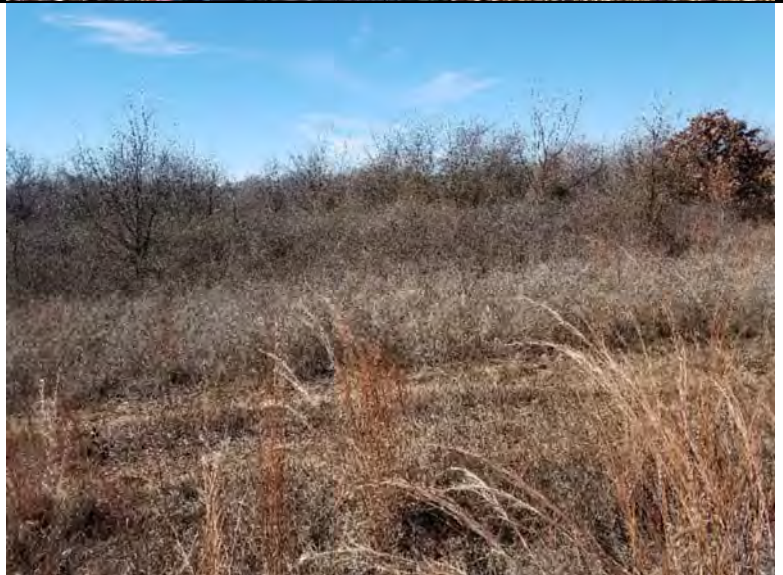
## Photograph 14

Edge of prairie as transitions to areas dominated by woody vines and shrubs as viewed to west from northeast portion of Site.

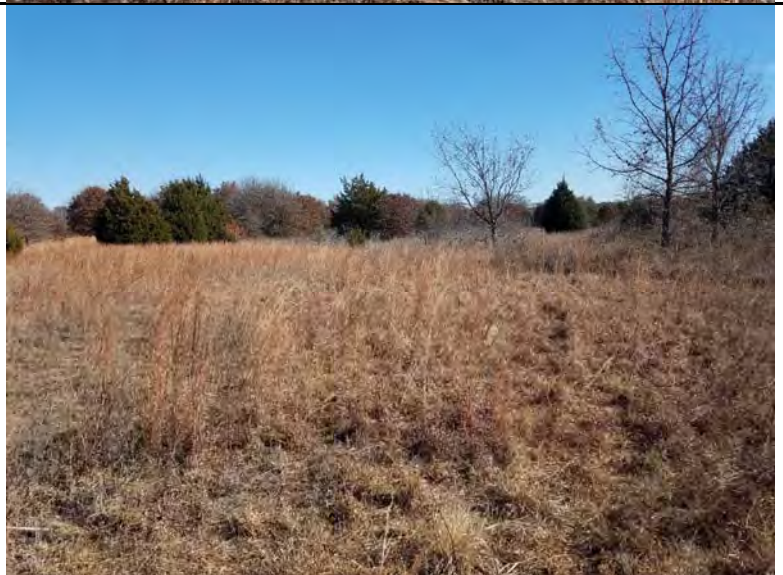
## Photograph 15

Prairie habitat in linear area in central portion of Site. View is to the east.
