# Environmental Conservation Commission

1. Smith Tract Conservation Development - Consider a recommendation to the Planning and Zoning Commission and Town Council of an Open Space Management Plan for the proposed Smith Conservation Development. The

# SMITH TRACT

## OPEN SPACE MANAGEMENT PLAN

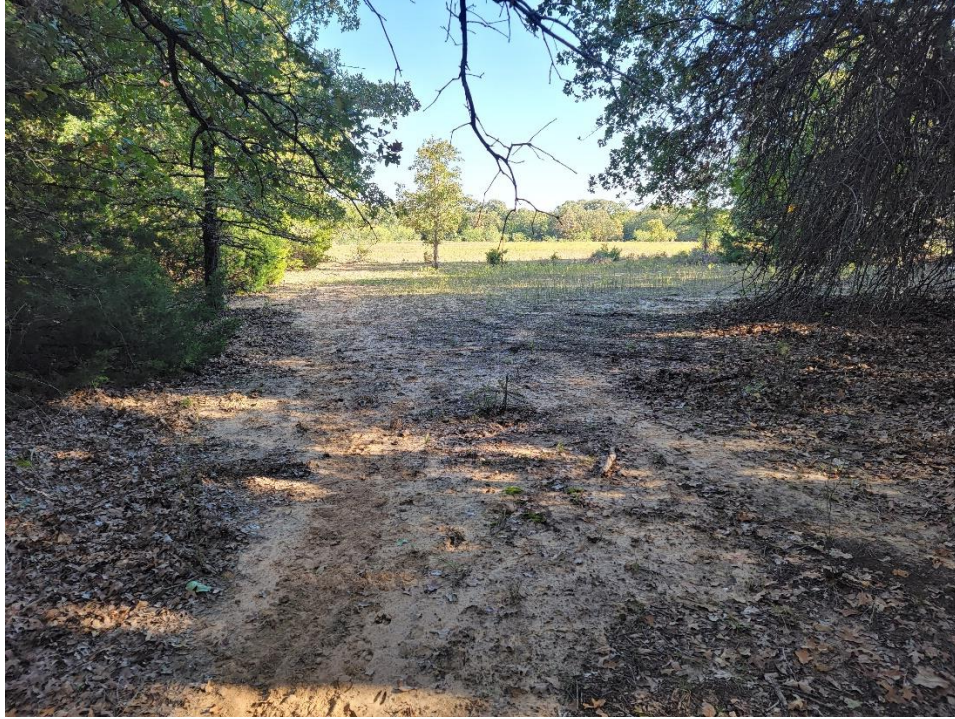
**P9** – View of Assessment Area at OP 10, showing riparian corridor along an unimproved ranch road Right-of Way (ROW).

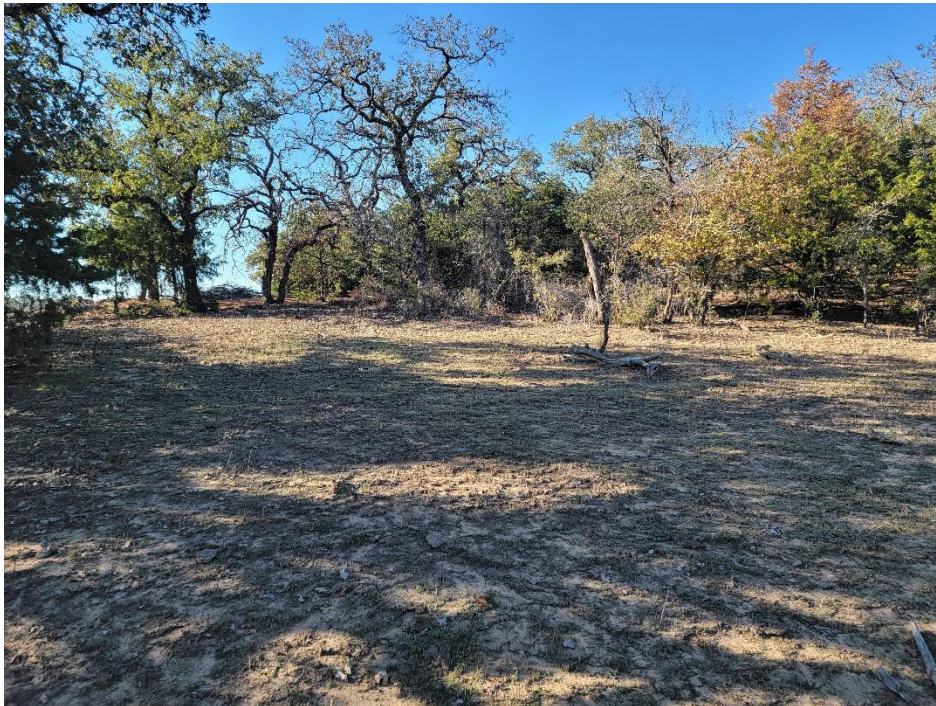
**P10** - View of Assessment Area at OP 12, showing an overgrazed pastureland and woodland edge.

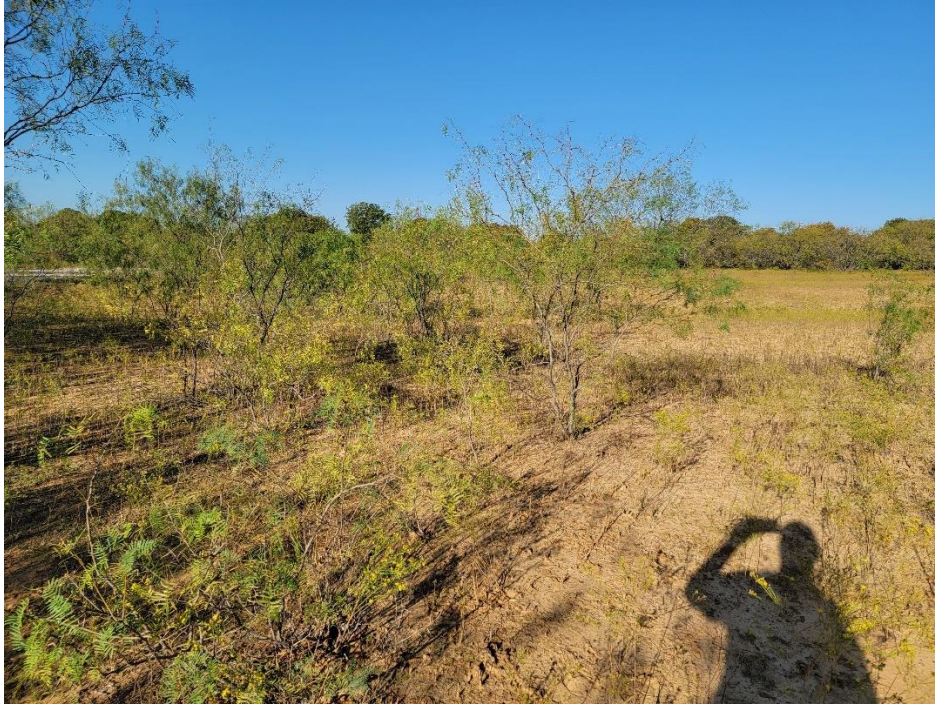
**P11** – View of Assessment Area at OP 13, showing interspersed scrub/shrub vegetation.

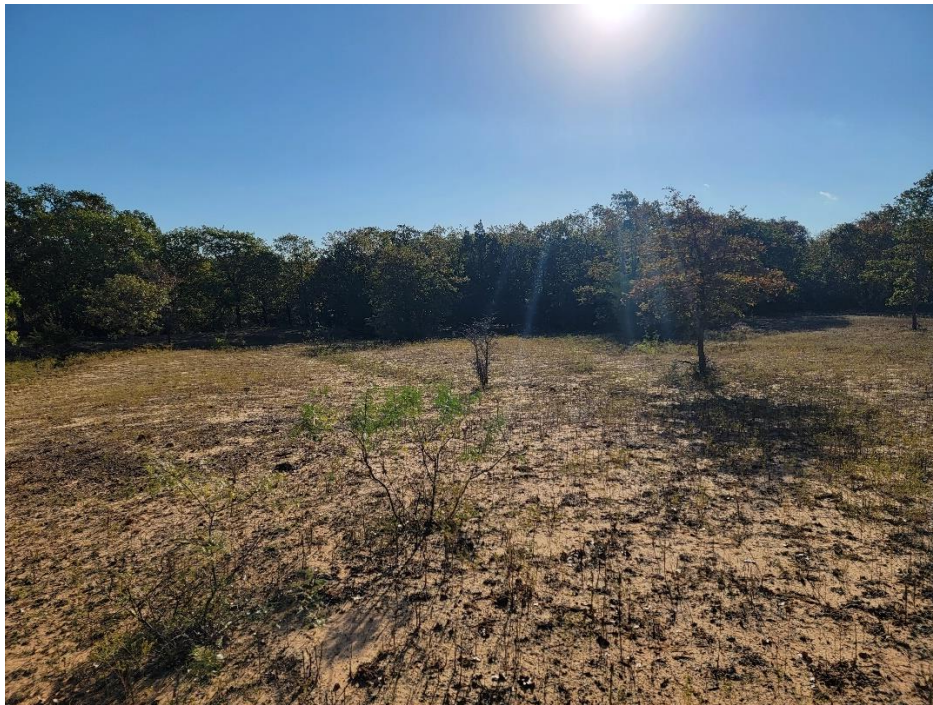
**P13** – View of Assessment Area at OP 17, showing transitional zone between woodland area and bare ground.

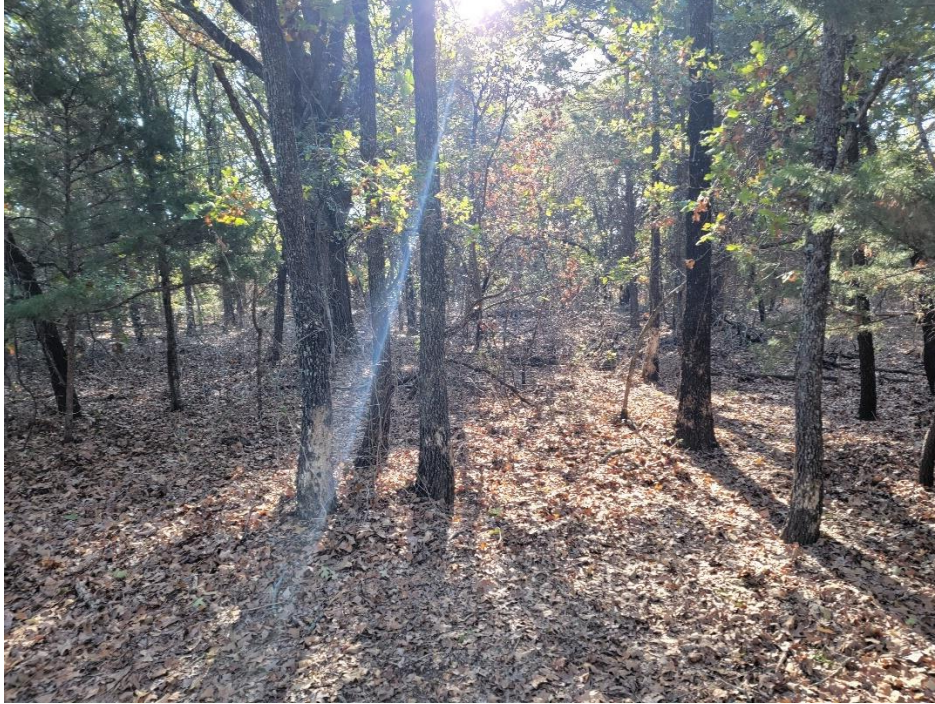
**P14** – View of Assessment Area near the center, showing open canopy woodland with typical leaf litter.

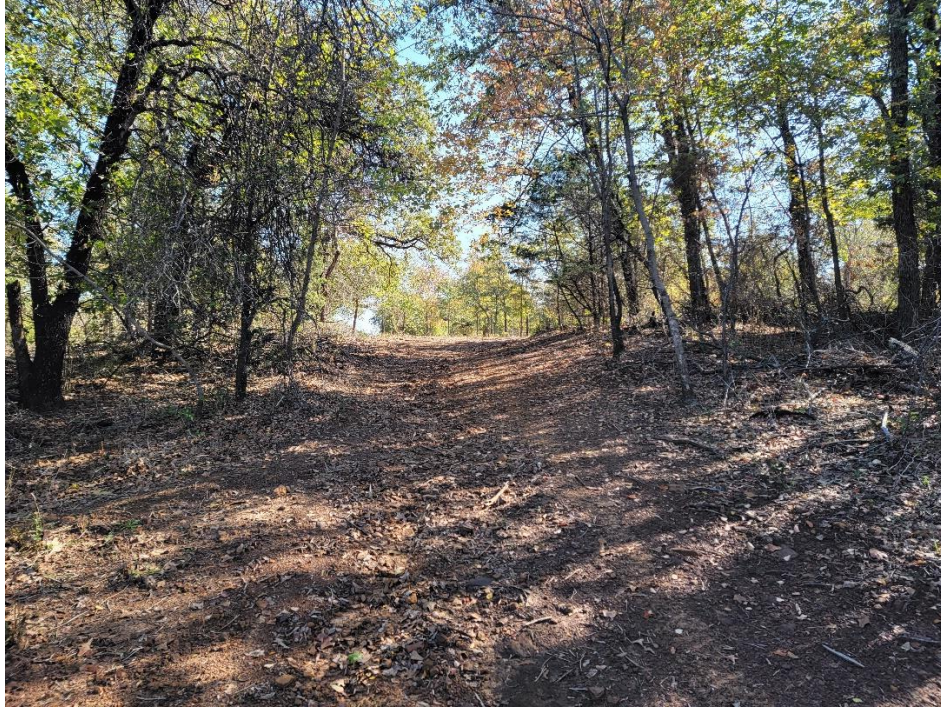
**P20** - View of Assessment Area at OP 23, from an upland swale showing a cleared unimproved ranch road.
